# Manhole Inspection Summary

Manhole # S08CC2001MH

**Location** Address: **3918 GLENGYLE AVE**

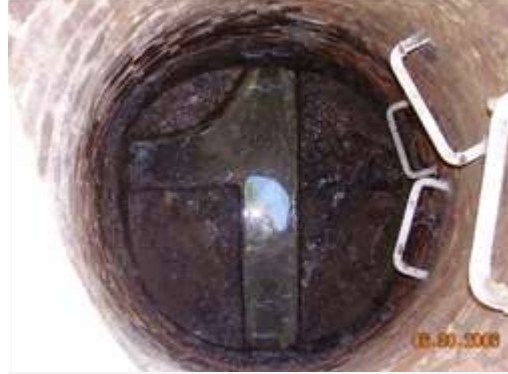
Top View

Evidence of surcharge - Bench debris.

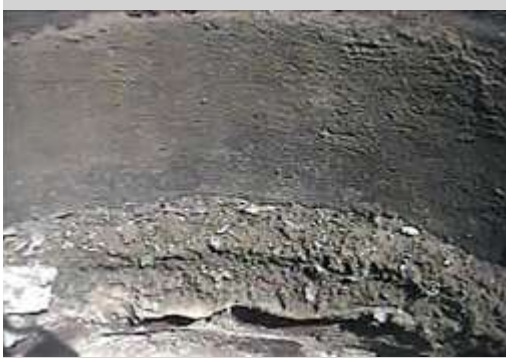
Defect

☒ **Leaks**

Condition: ☐ Sound ☐ Cracked ☐ Root Intrusion ☐ Loose Brick ☒ **Deteriorated**

Infiltration: ☐ None ☒ **Joint** ☐ Cracks ☒ **Mortar** ☐ Roots ☐ Wall

Frame leaks. Adjustment deterioration and infiltration.

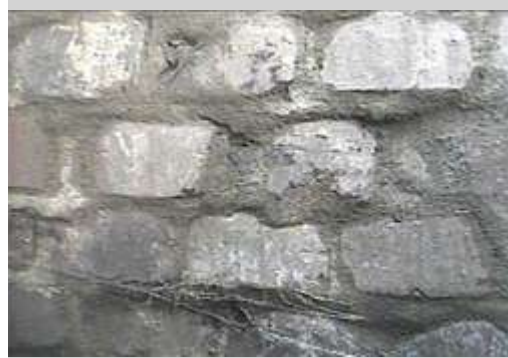
Defect

Condition: ☐ Sound ☐ Cracked ☒ **Root Intrusion** ☐ Loose Brick ☐ Deteriorated

Infiltration: ☐ None ☐ Joint ☐ Cracks ☒ **Mortar** ☒ **Roots** ☒ **Wall**

Barrell root intrusion and infiltration.

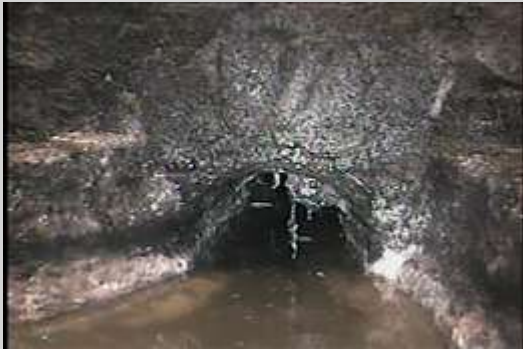
### 8 in. Circular Gravity Sewer Pipe Out @ 12 O'Clock

Barrel infiltration

Deposits: ☐ None ☐ Mud ☐ Sludge ☒ **Debris** ☐ Grease

Silt Depth: **1** (in.) Deposits Extent: **Heavy**

Infiltration: **Evidence** Pipe Seal Cond: **Unknown**

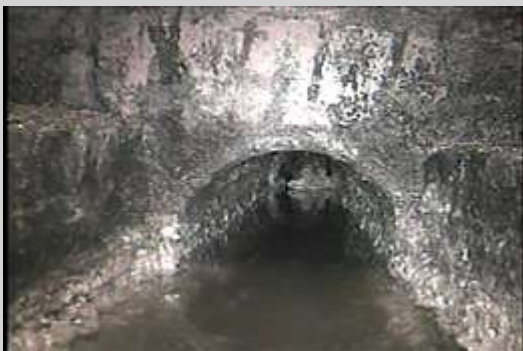
### 8 in. Circular Gravity Sewer Pipe In @ 6 O'Clock

Barrel infiltration.

Deposits: ☐ None ☐ Mud ☐ Sludge ☒ **Debris** ☐ Grease

Silt Depth: **1** (in.) Deposits Extent: **Heavy**

Infiltration: **Evidence** Pipe Seal Cond: **Unknown**

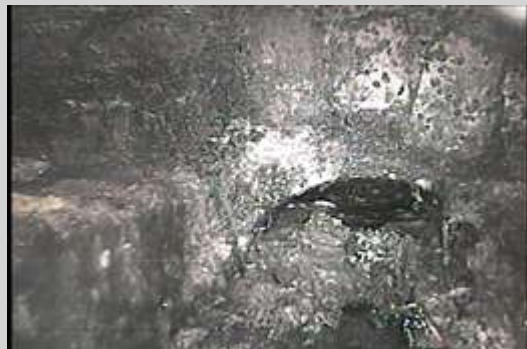
Pipe In @ 9 O'Clock

Roots

Deposits: ☐ None ☐ Mud ☐ Sludge ☒ **Debris** ☐ Grease

Silt Depth: **6** (in.)

Infiltration: **Evidence**
